Commonwealth Edison Company
Byron Generating Station
4450 North German Church Road
Byron, IL 61010-9794
Tel 815-234-5441

Byron Station, Unit 2
Facility Operating License No. NPF-66
NRC Docket No. STN 50-455

Subject: Licensee Event Report (LER) 2000-001-00

Enclosed is an LER concerning the Byron Station Unit 2 automatic reactor trip on January 13, 2000. This event is reportable to the NRC in accordance with 10 CFR 50.73 (a)(2)(iv).

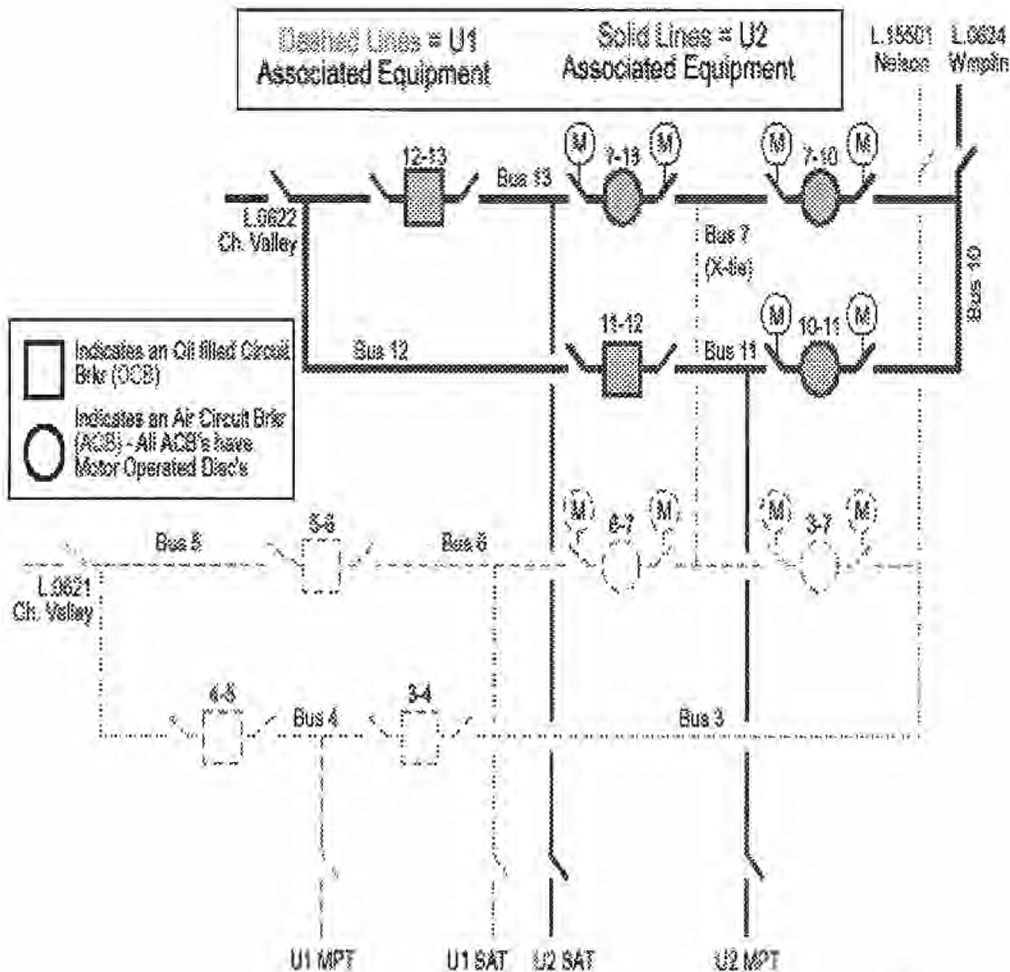
FIGURE 1 - LINE DIAGRAM OF BYRON STATION'S SWITCHYARD

The two Units at Byron Station have a common 345 Kv switchyard that is configured into two ring busses to afford reliability and redundancy of offsite power supplies. Figure 1 depicts a line diagram of Byron Station's switchyard. Two 345 Kv offsite transmission lines are connected to each unit's ring bus. The Unit 1 lines are numbered 0621 and 15501 and the Unit 2 lines are numbered 0622 and 0624. Line 0621 and 0622 are routed on the same transmission towers from the Cherry Valley substation into the Byron Station switchyard. Each line is provided with fault isolation capability from the ring bus through use of switchyard circuit breakers.

At 0059 hours on January 13, 2000, a static line on line 0621 broke and fell across the B phase of line 0622 thereby causing an electrical fault. Unit 2 received a line 0622 direct transfer trip alarm due to a phase B fault on line 0622. The direct transfer trip signal opened Oil Circuit Breakers (OCBs) 11-12 and 12-13 to isolate the line fault in the Byron Station switchyard. Due to the redundant offsite power supply (i.e., line 0624) the event should have terminated at this time without further interruption to unit operations. However, Unit 2 also received an unexpected Main Generator [TB] (MG) load rejection trip signal. The load rejection circuit provided a signal to actuate MG lockout relay 86G2A, which opened Air Circuit Breaker (ACB) 10-11 and automatically tripped the Unit 2 turbine [TA]. A turbine trip automatically generates a reactor trip above 30% power.
